Appendix C: Hazards and
Mitigation PowerPoint
Summarizing City's
Flood/Fire Mitigation
Actions since 2012

Hazards & Mitigation

City of Colorado Springs
July 29, 2015

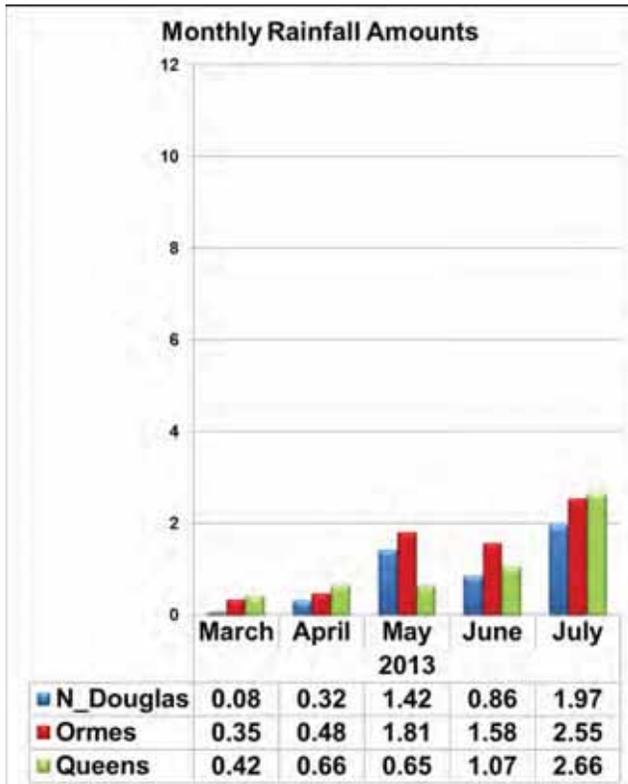
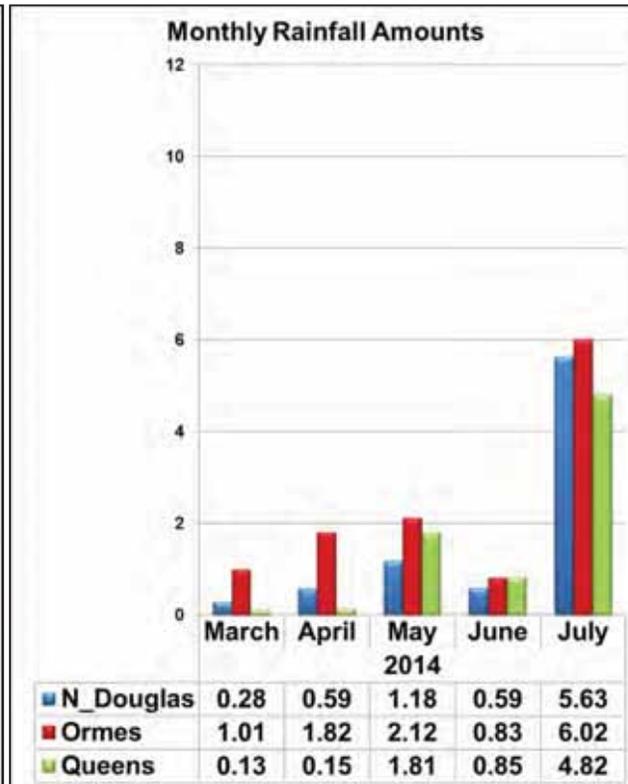
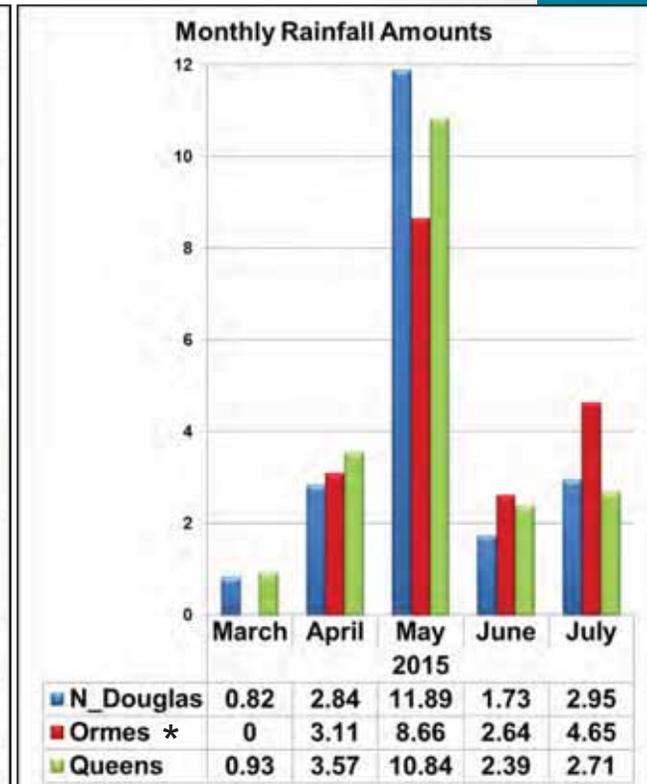
Waldo Canyon Burn Scar Rainfall above Colorado Springs 2013 - 2015

Three USGS rain gages are located on the Waldo Canyon Fire Burn Scar above Colorado Springs on Camp Creek (Ormes and Queens) and North Douglas Creek. When compared to 2013 and 2014, the 2015 monsoon season has begun with a significant increase in precipitation on the burn scar. Rainfall amounts in May 2015 surpassed the September 2013 rains, and every month in 2015 has surpassed the same month in the previous 2 years, thus far.

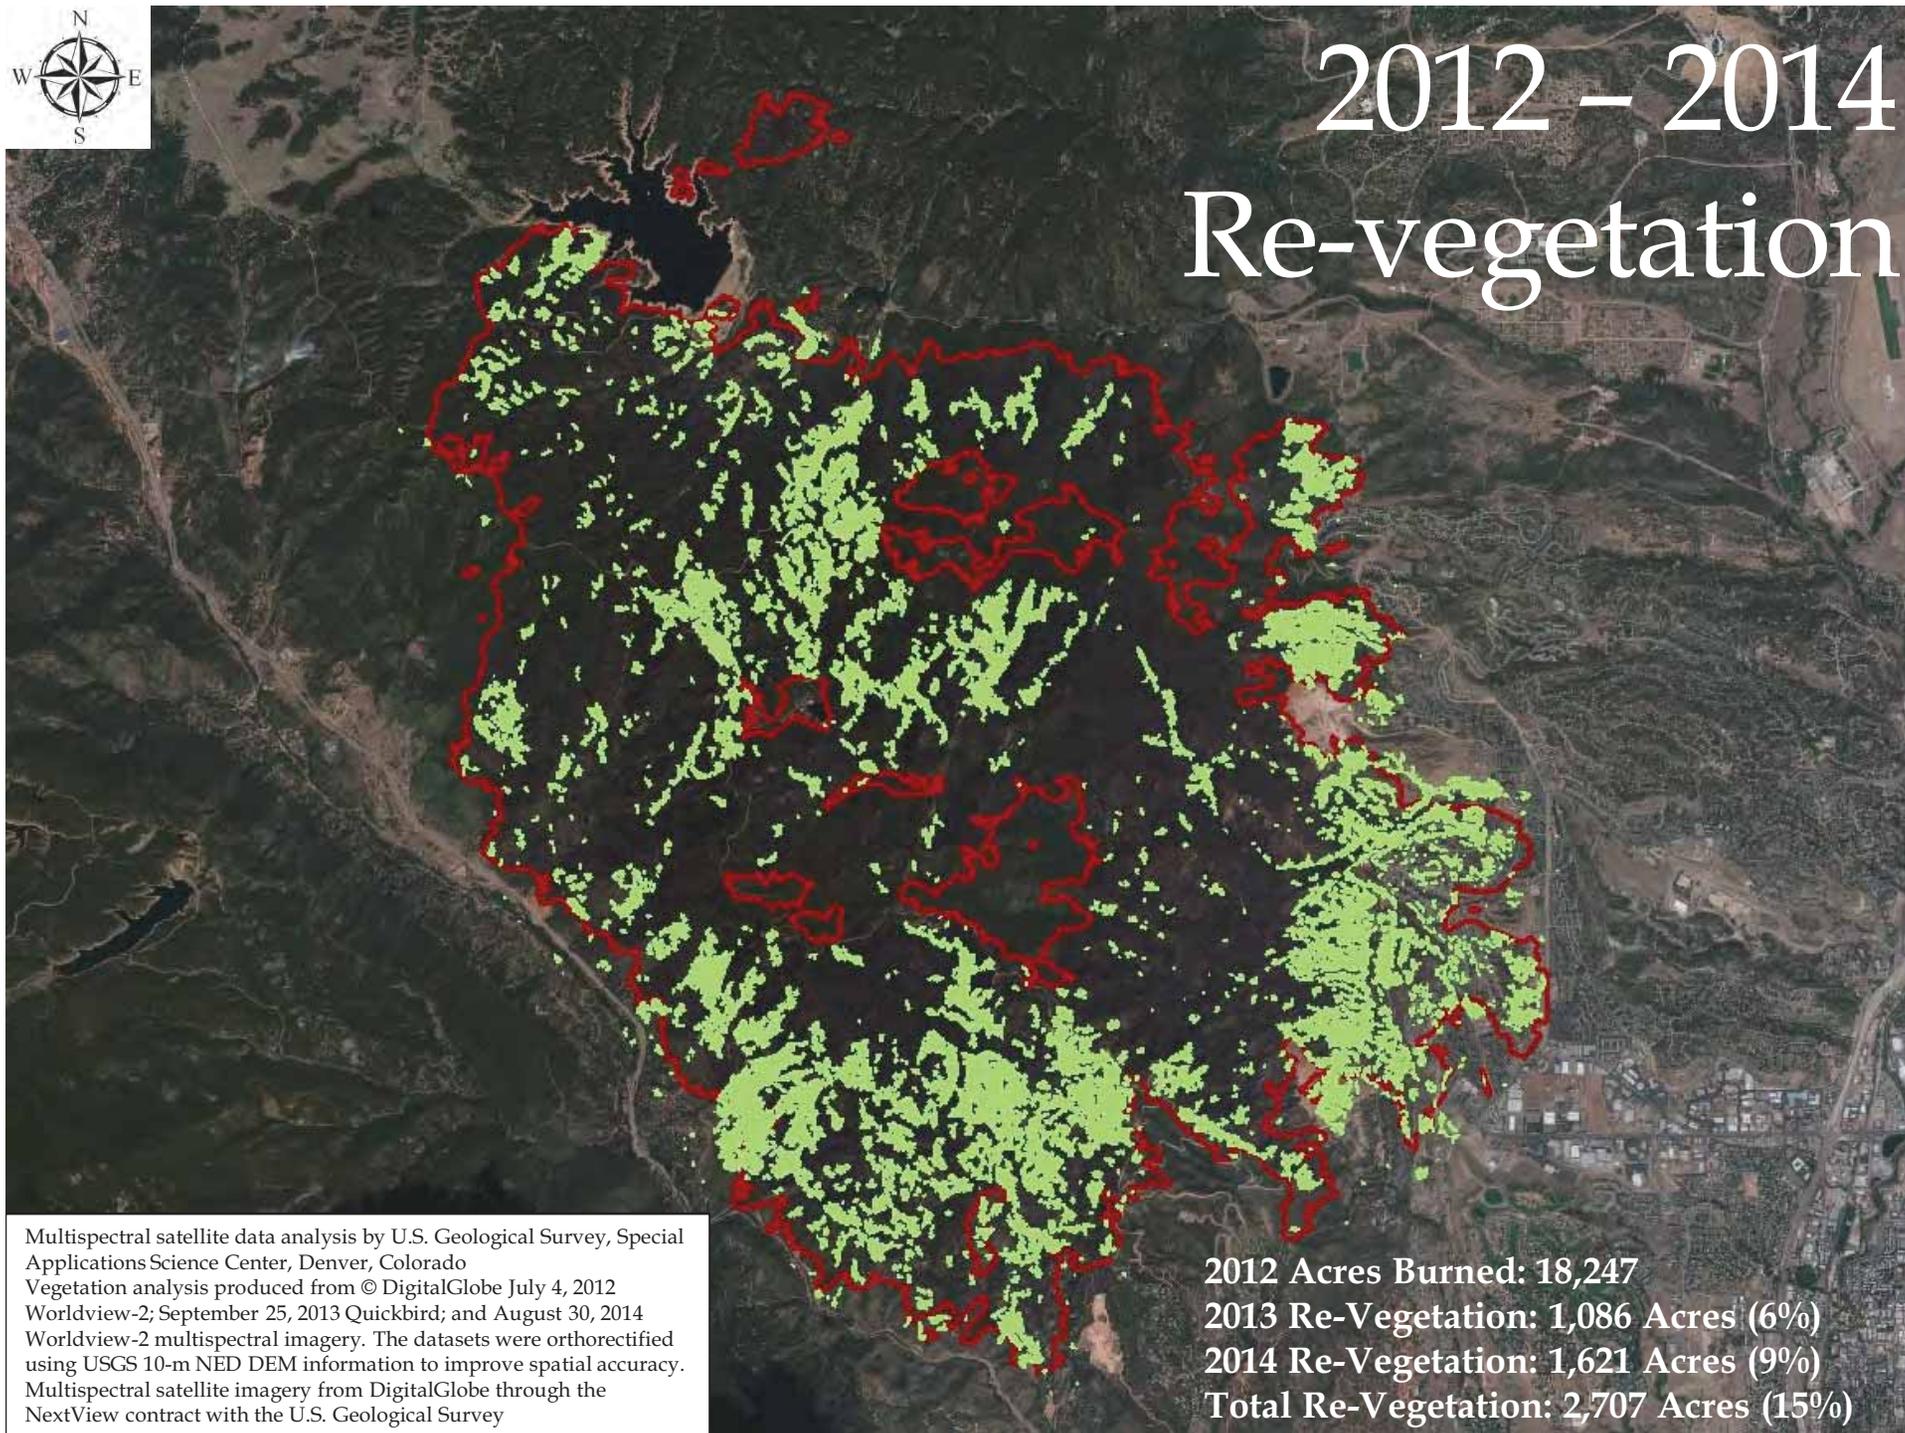
2012 – 2014 Re-vegetation

Multispectral satellite data analysis by U.S. Geological Survey, Special Applications Science Center, Denver, Colorado
Vegetation analysis produced from © DigitalGlobe July 4, 2012 Worldview-2; September 25, 2013 Quickbird; and August 30, 2014 Worldview-2 multispectral imagery. The datasets were orthorectified using USGS 10-m NED DEM information to improve spatial accuracy. Multispectral satellite imagery from DigitalGlobe through the NextView contract with the U.S. Geological Survey

2012 Acres Burned: 18,247
2013 Re-Vegetation: 1,086 Acres (6%)
2014 Re-Vegetation: 1,621 Acres (9%)
Total Re-Vegetation: 2,707 Acres (15%)

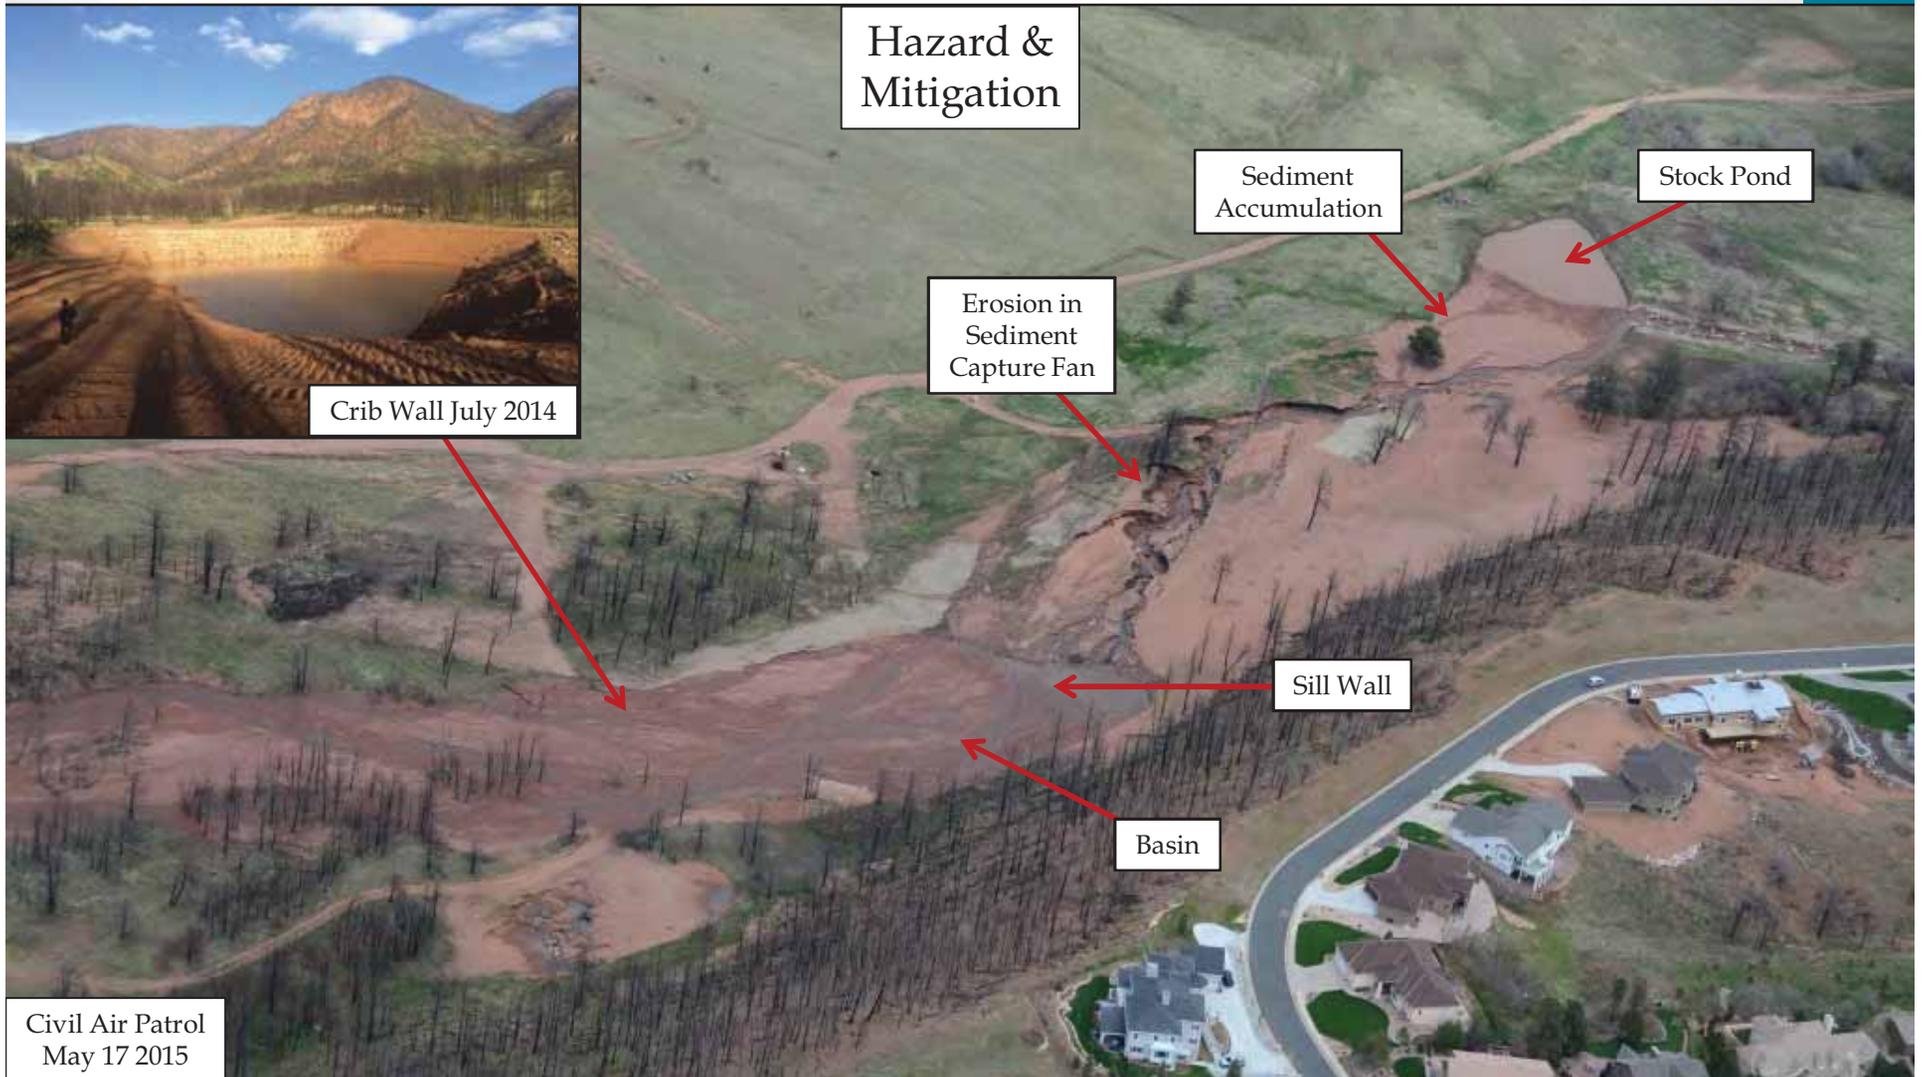
N. Douglas Sediment Complex Flying W

North Douglas Creek on Flying W Ranch: The large sediment catchment complex was completely filled with sediment during the rains. The flatter fan area below the basin became incised by water eroding a new channel, and the stock pond is over 50% filled with sediment. The in-channel drop ponds did work well, but water circumvented the structures and created a new channel.

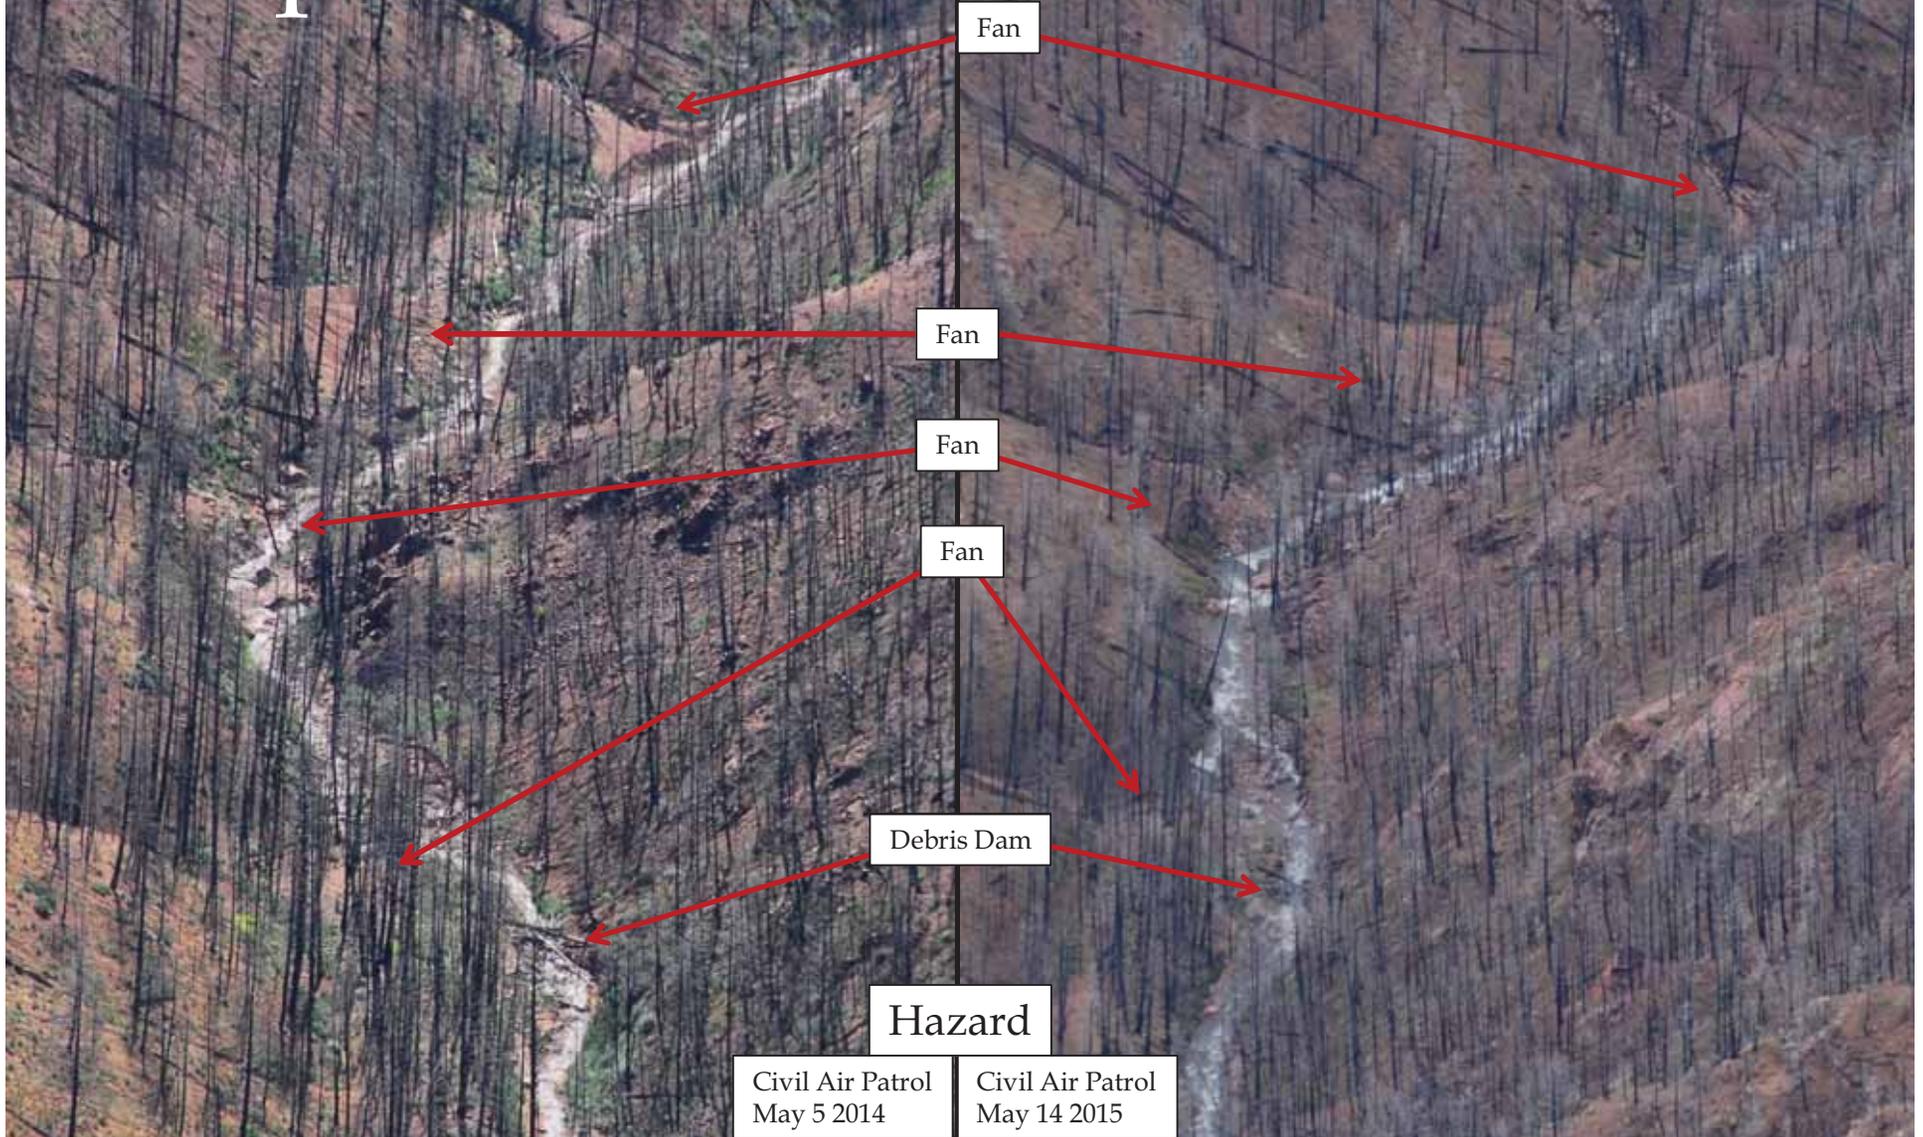
Camp Creek Alluvial Fans Area

Camp Creek/Queen's Canyon: Comparing 2014 to 2015, an area where alluvial fans formed in 2013 has changed in 2015, with sediment moving into Camp Creek. Head cutting, gullying, and rilling continue to contribute large quantities of sediment to the area. A debris dam that formed in 2014 remained intact in 2015.

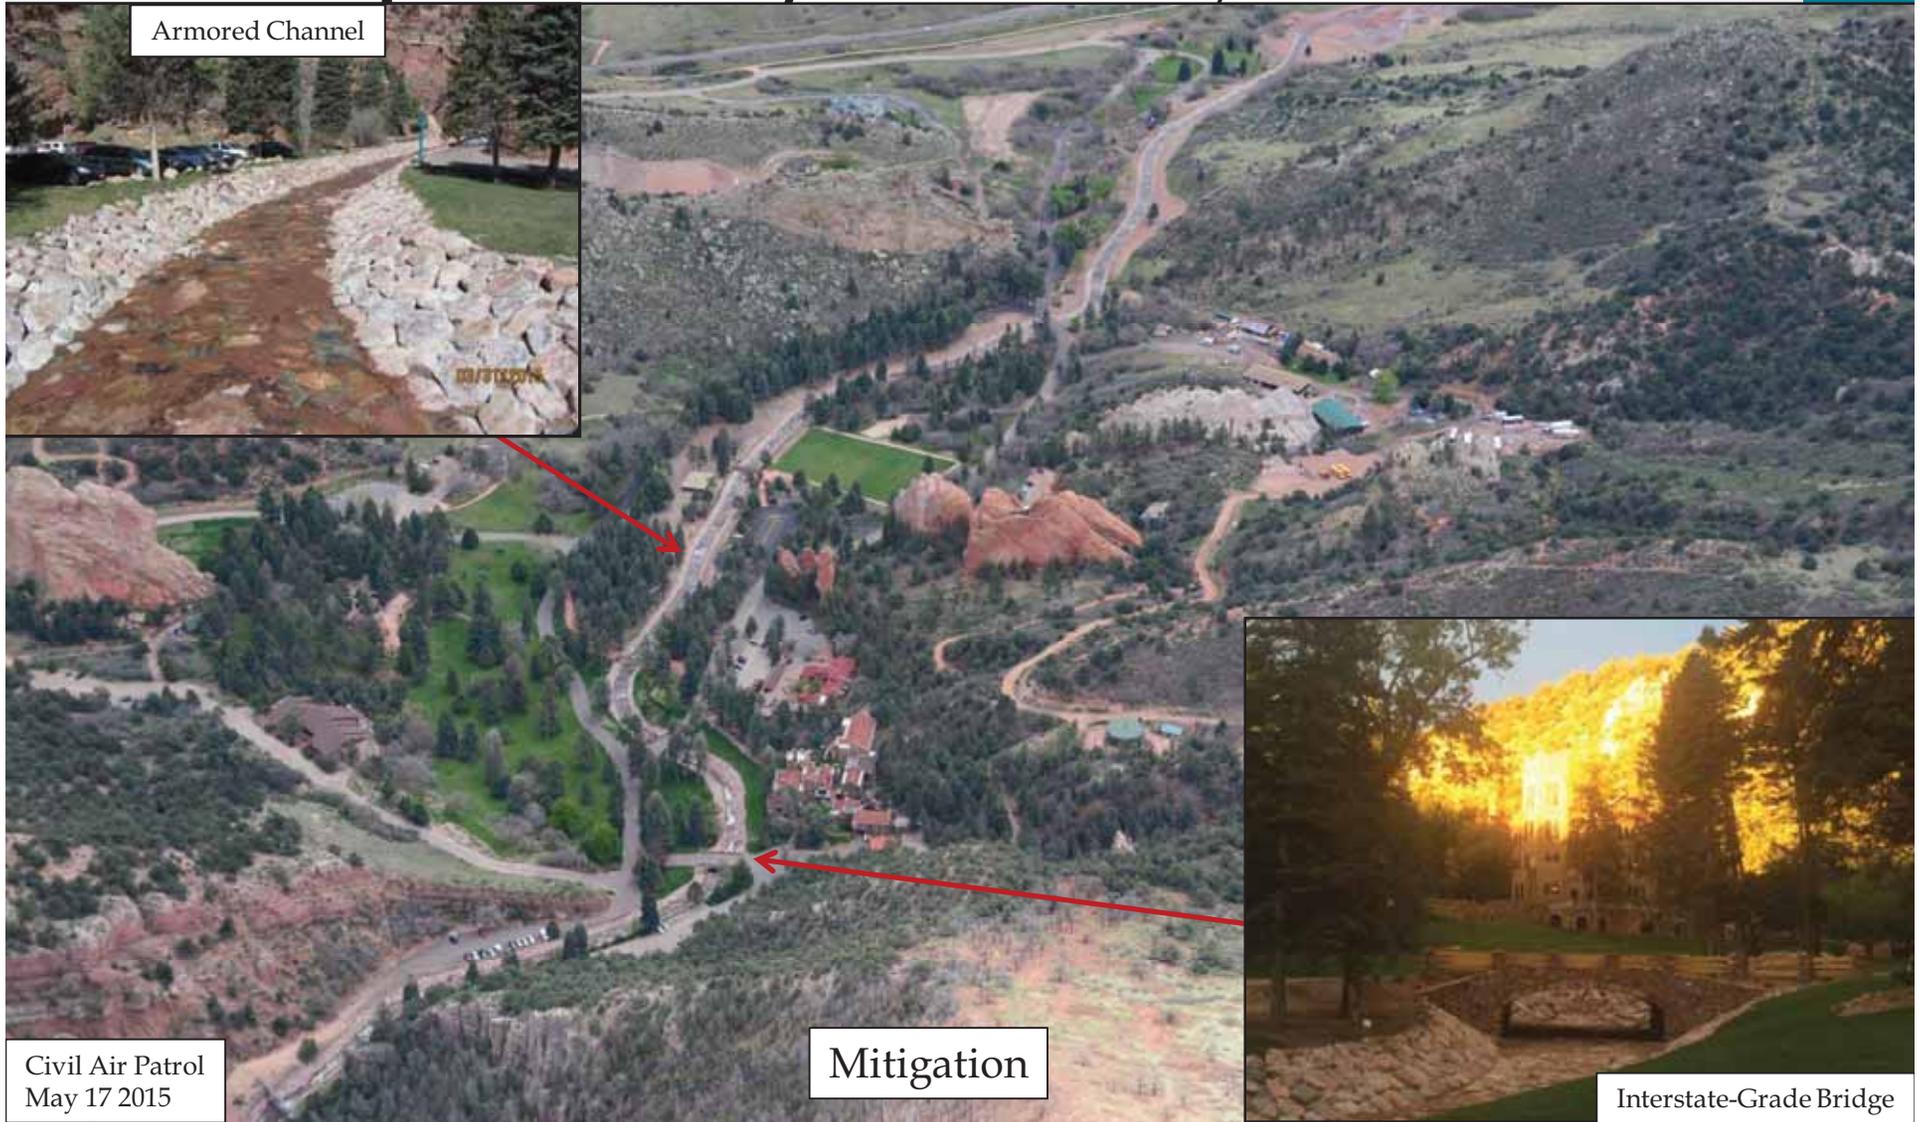
Camp Creek / Glen Eyrie

Armored Channel

Interstate-Grade Bridge

Camp Creek/Glen Eyrie: The Navigators armored the entire Camp Creek channel from the lower net to the border with Garden of the Gods; Colorado Springs Public Works had the channel armored to the basin. This protective measure worked well for moving water and sediment through the Glen to keep them safe.

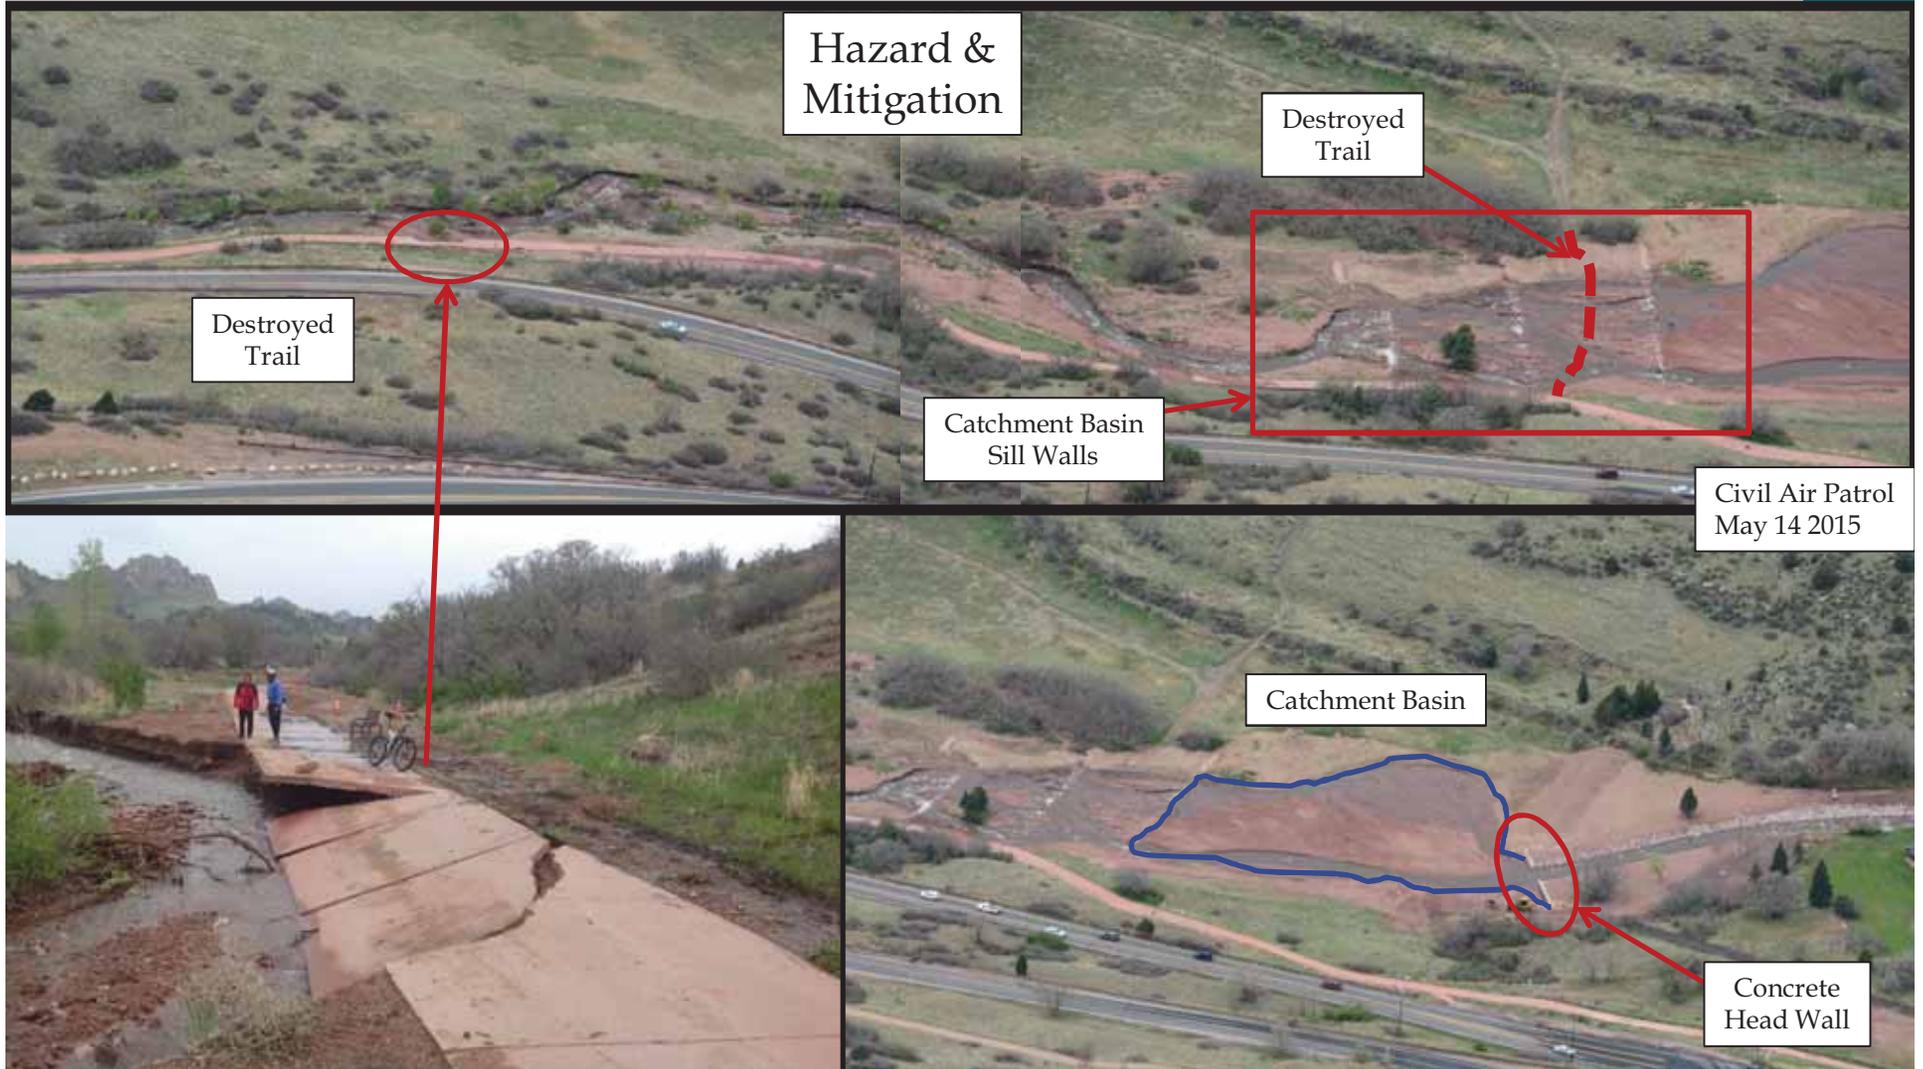
Camp Creek/GoG Park

Camp Creek/Garden of the Gods Park: During the May 2015 rains, sediment from Camp Creek moved down the improved channel into the basin, quickly filling the basin and destroying two trails. Public Works Streets crews worked to keep some water flowing, but a new channel was cut by the flood waters.

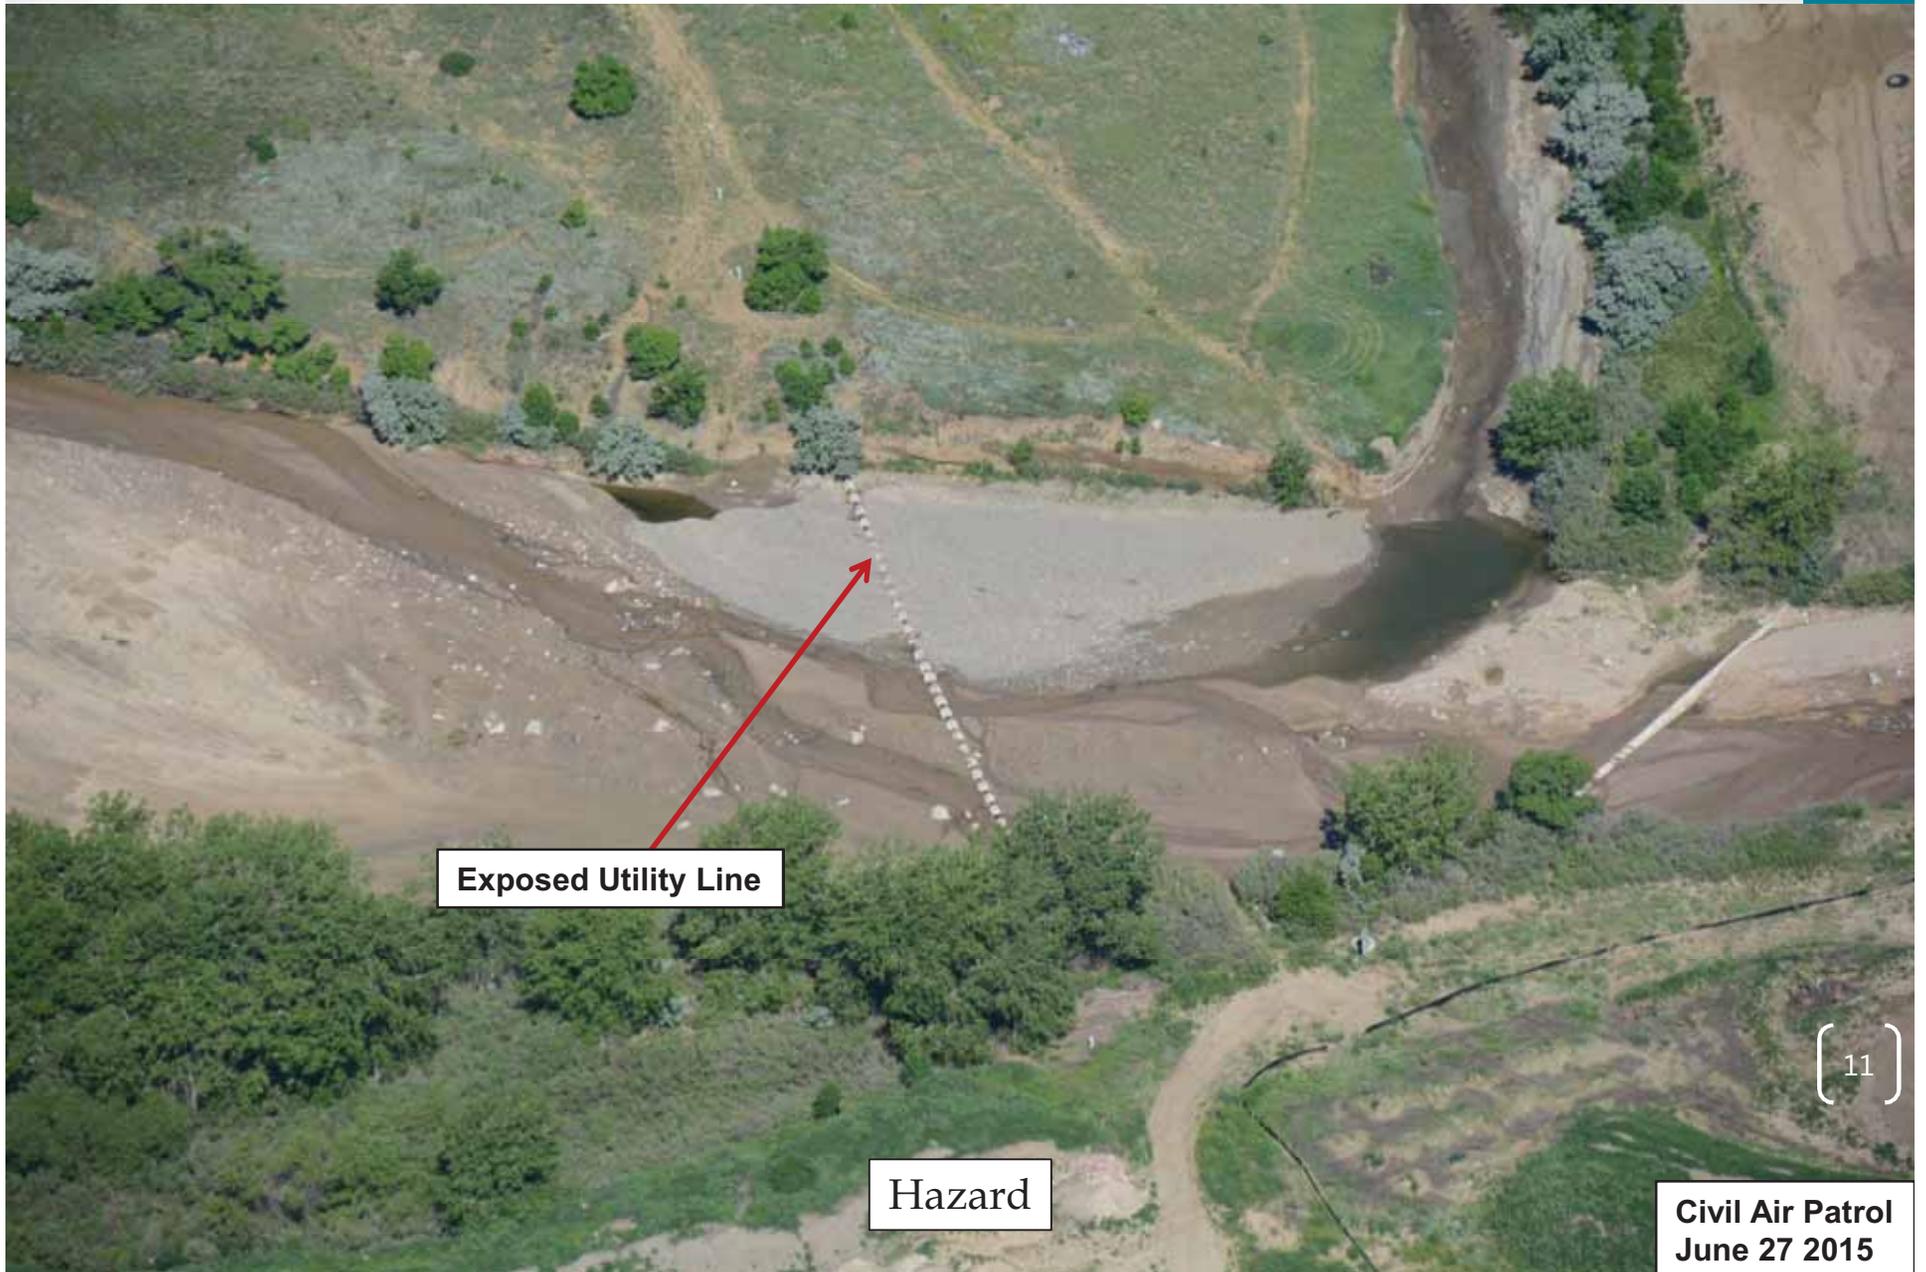
Sand Creek

Exposed Utility Line

Hazard
